Immediate Graft™

Case Presentation of immediate implant placement with the buccal wall missing in the esthetic zone using Immediate Graft™

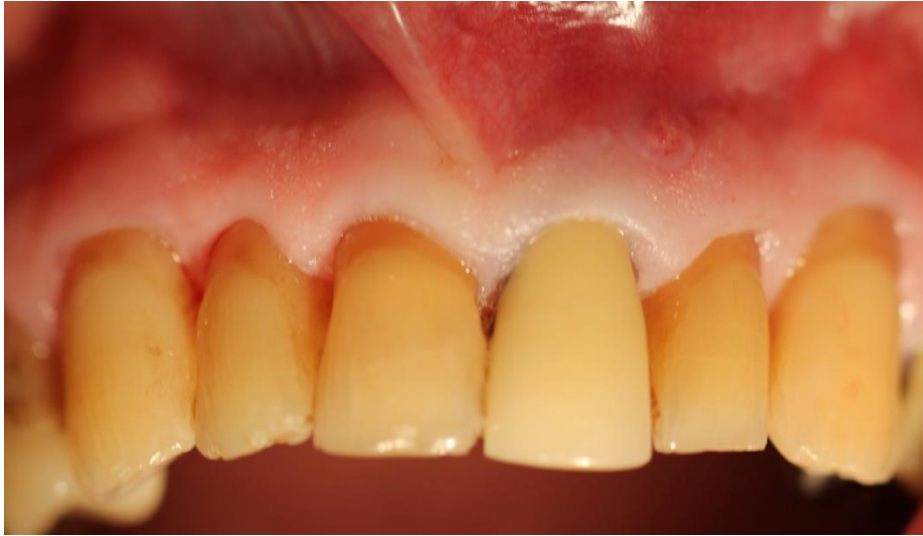
Patient presents with a draining fistula between 9 and 10.

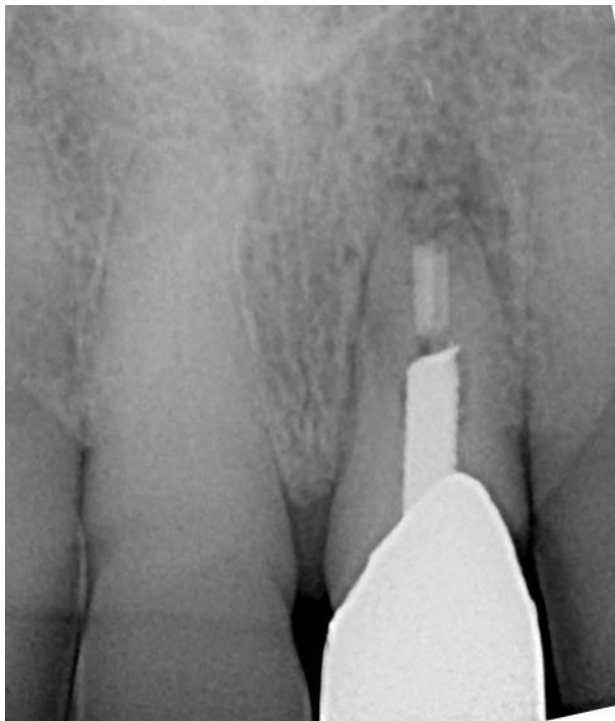
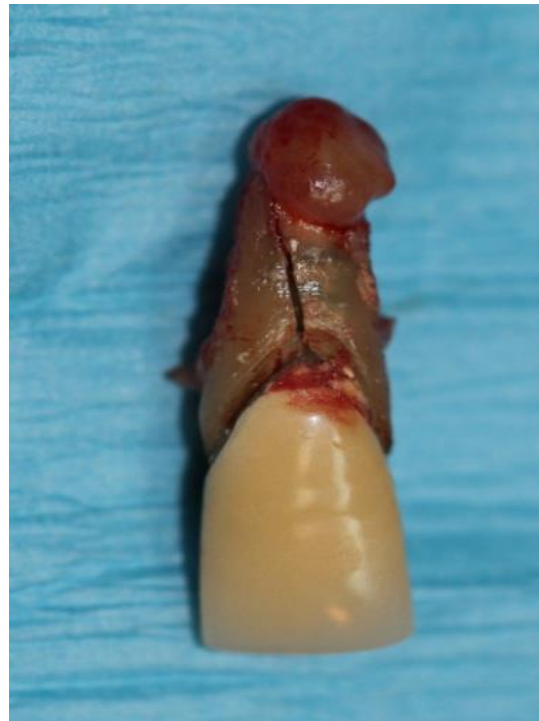
The diagnosis is a failed endodontic therapy tooth #9. Upon extraction, the root fracture is found

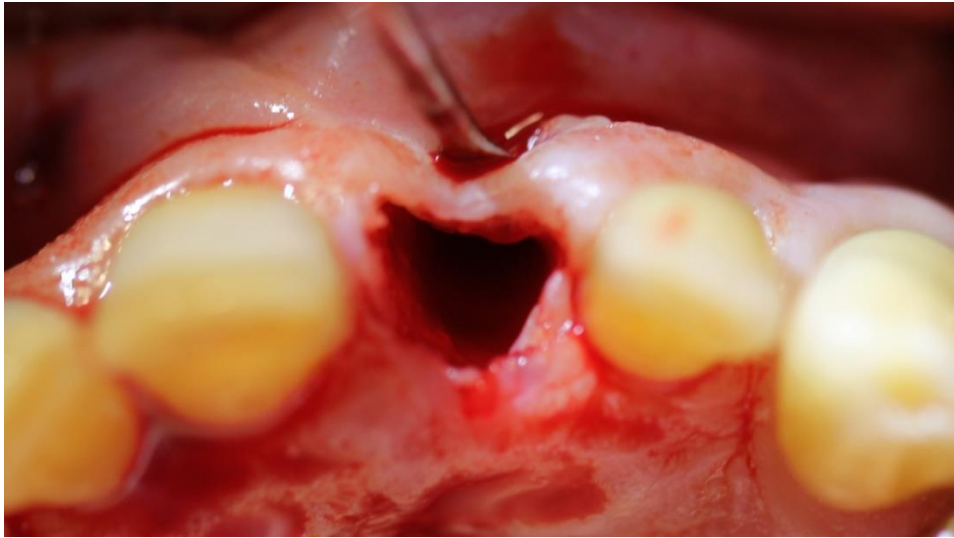
The root fracture destroyed the buccal wall of the extraction socket. Many practitioners advise against immediate implant placement when either active infection is present or the loss of a socket wall. However, with a graft material that is resistant to infection, not water soluble and provides a self membrane to unwanted cells, these lesions can now be predictably treated at the same time as immediate implant placement.

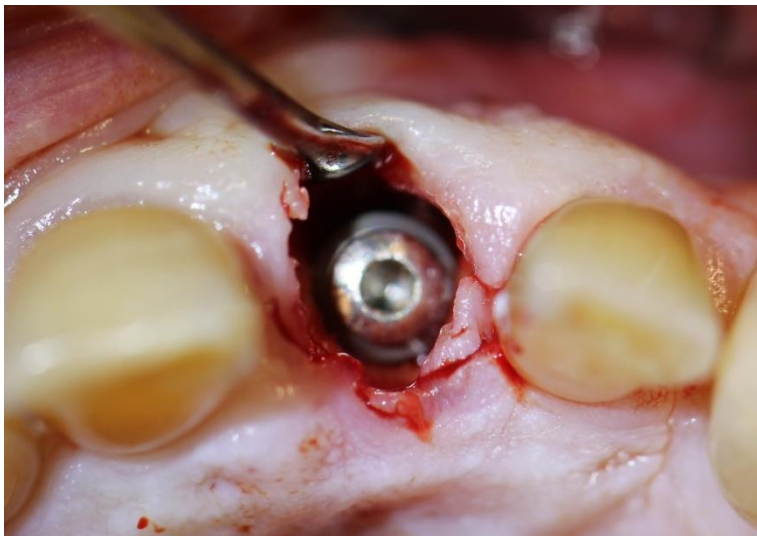
Void between implant and buccal gingiva and mucosa.

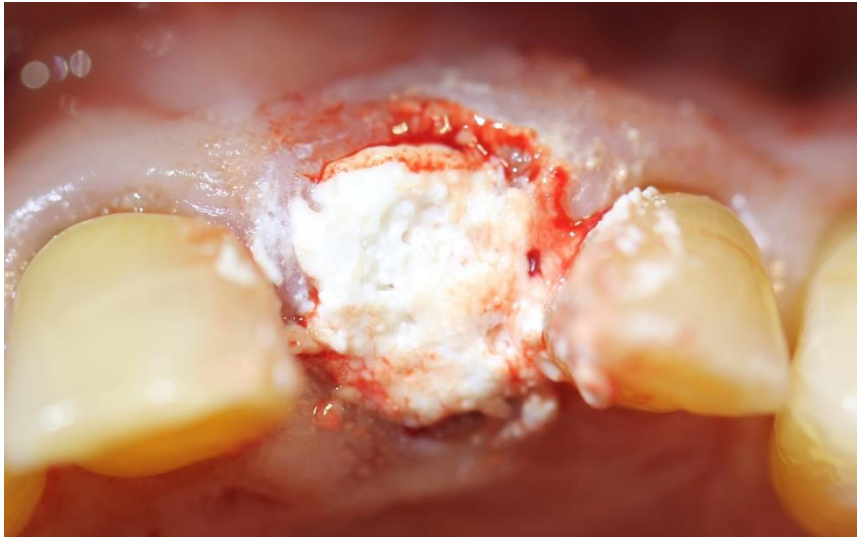
After grafting, excess graft material is removed from the extraction socket. The patient needs to be cautioned about applying pressure to the buccal surface in order to not displace the graft material

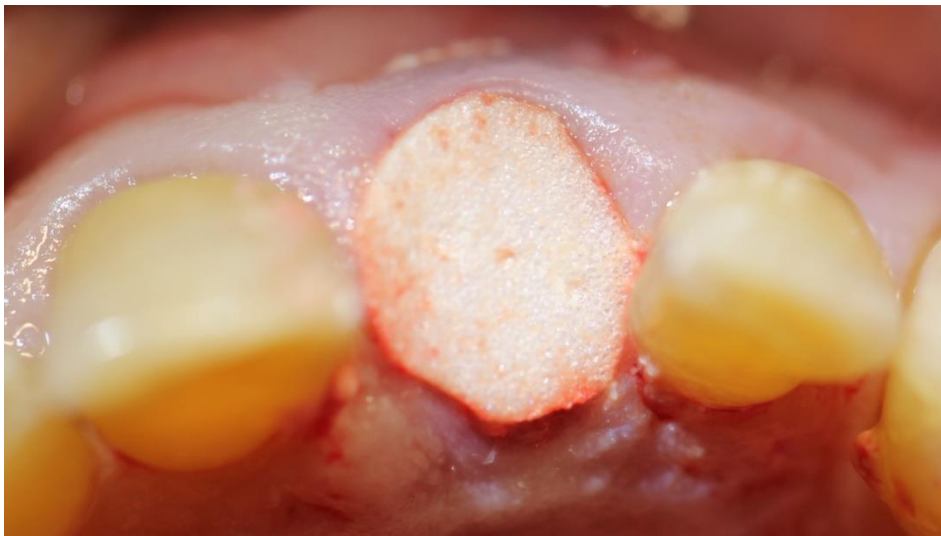
The extraction socket orifice is covered with a Socket Seal cut to fit.

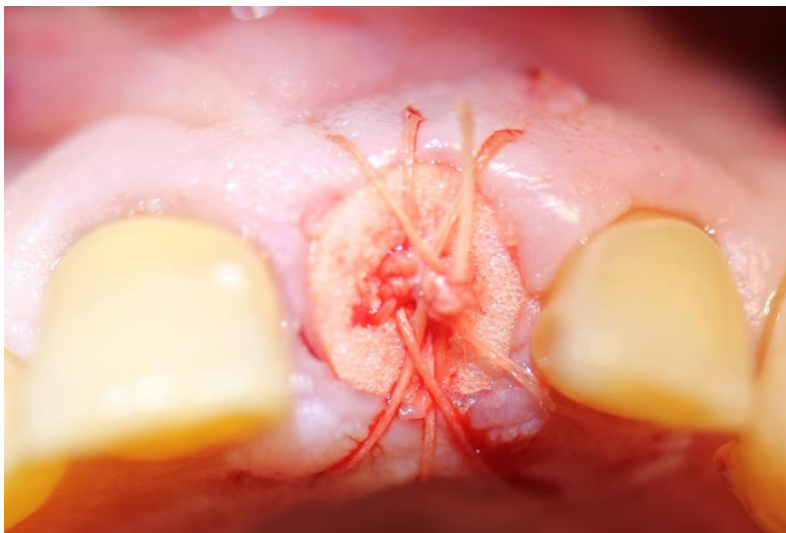
Suturing the Socket Seal to close the extraction socket orifice, seal in the graft material and exclude keratinized gingiva, epithelium and oral pathogens.

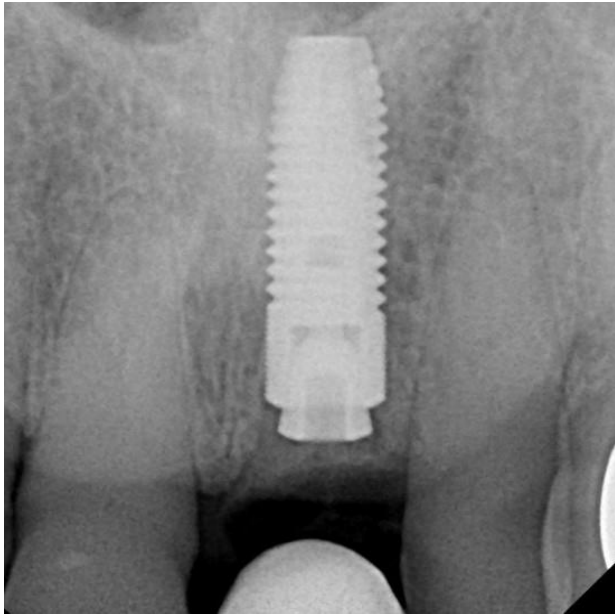
Radiograph of surgery complete.

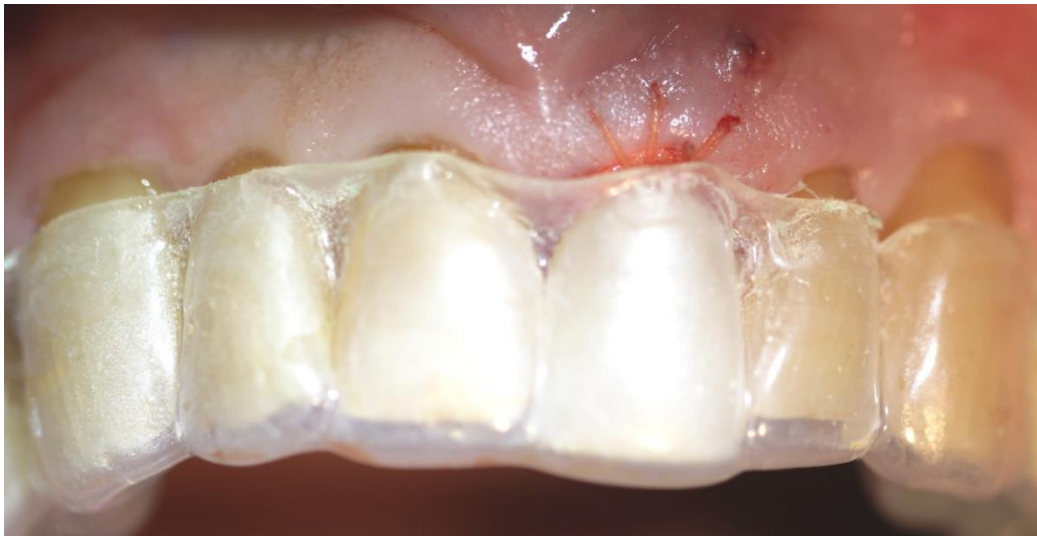
An Essex retainer is placed without contact with the pontic and Socket Seal. Immediate implants in the esthetic zone preferably receive immediate temporization. However, in this case with loss of the buccal wall immediate temporization would have increased the potential of implant failure.

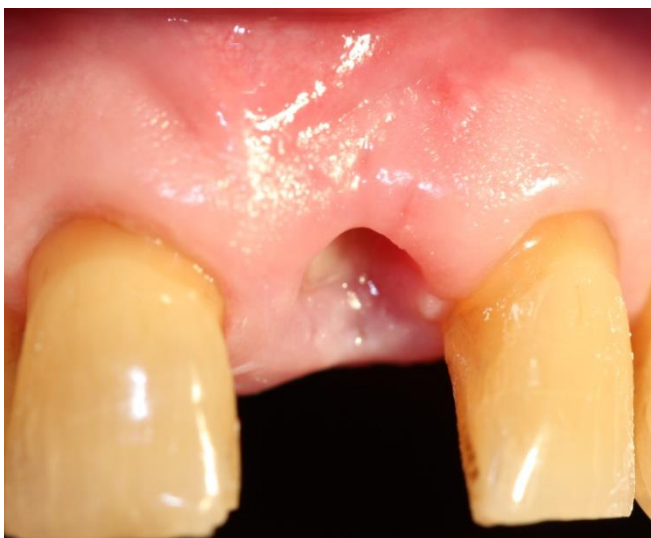
Socket Seal removed at 2 weeks, buccal view.

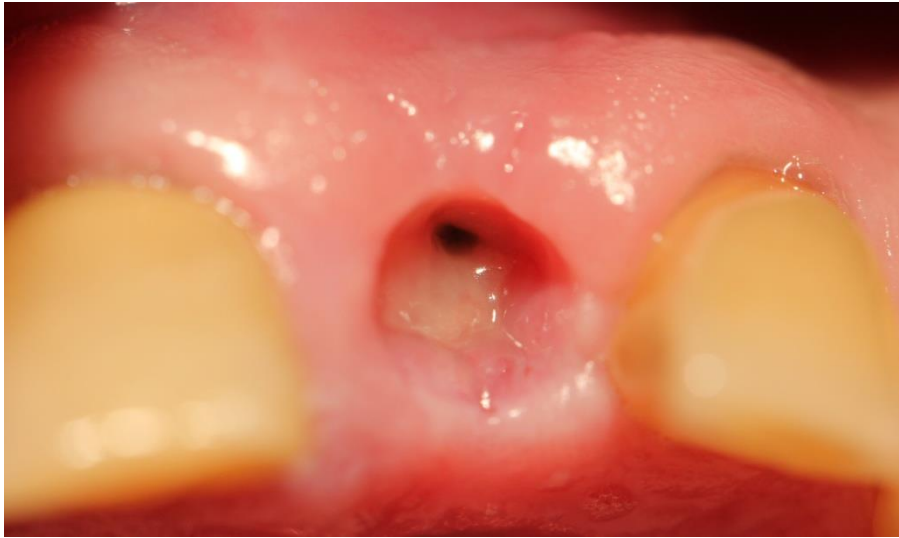
Socket Seal removal at two weeks. The gingival void can now be filled with an ovate pontic. The hole is the implant cover screw hex.

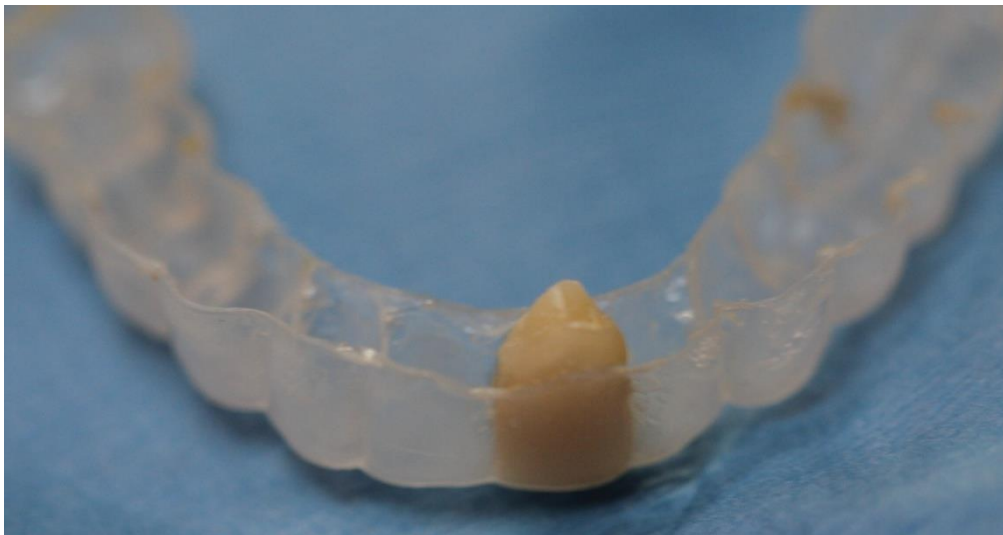
At the two weeks post operative appointment, Socket Seal is removed and restorative material is added to the pontic. The retainer is placed into position with the added restorative material which creates an ovate pontic.

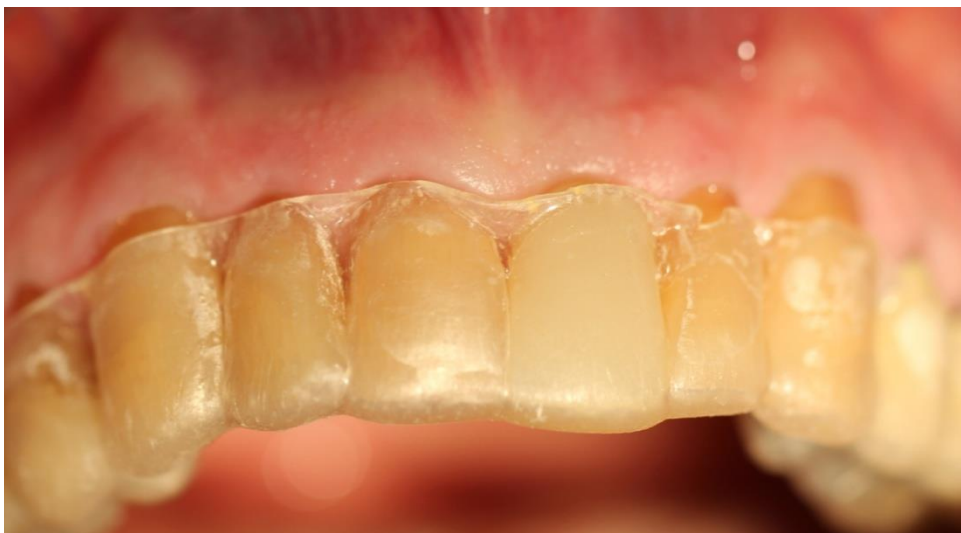
Essex retainer 5 weeks post implant placement.

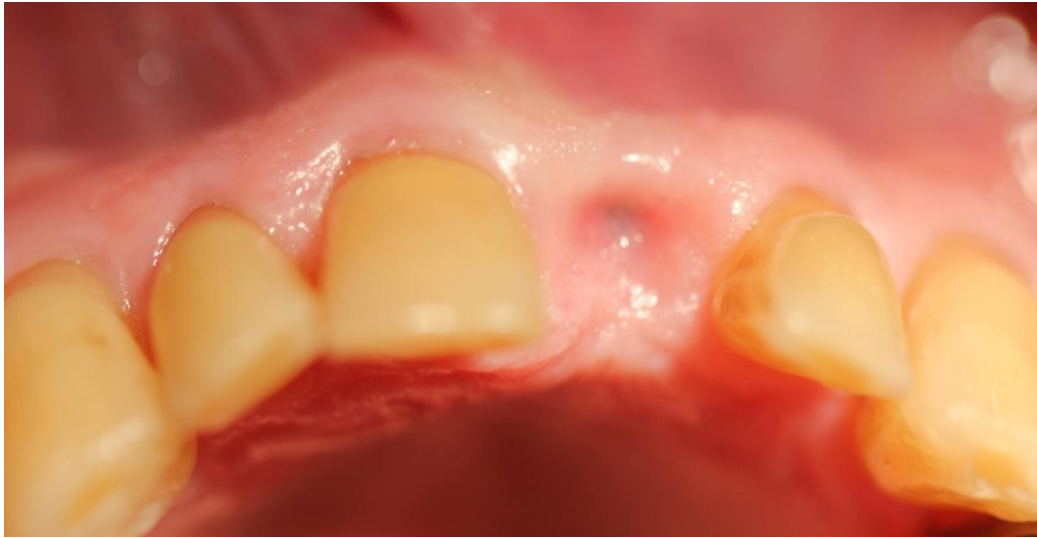
Gingival contours 5 weeks post implant placement

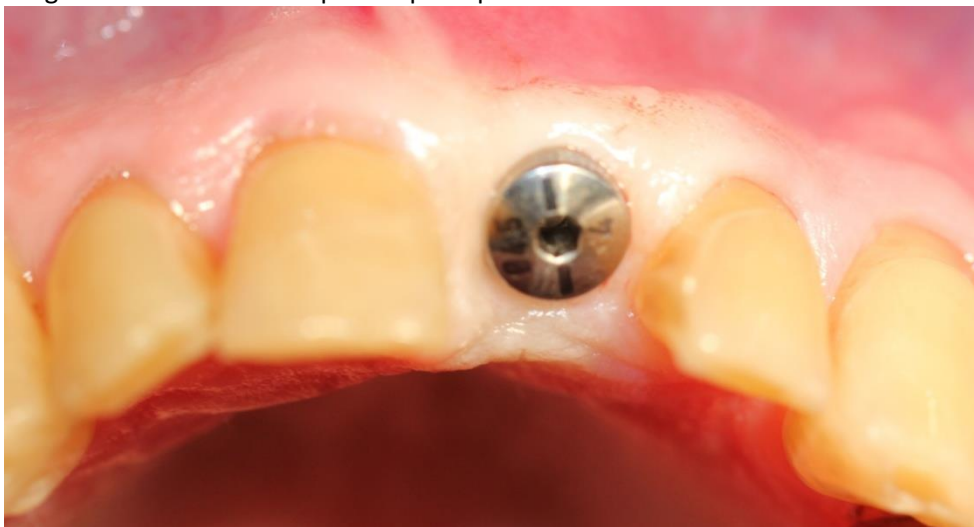
Healing abutment 5 weeks post implant placement.

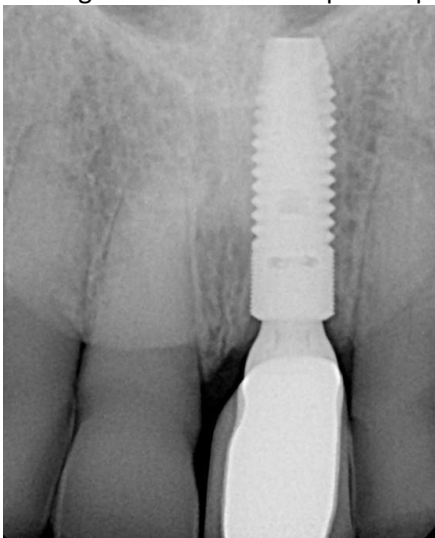
Final radiograph 14 weeks after implant placement.

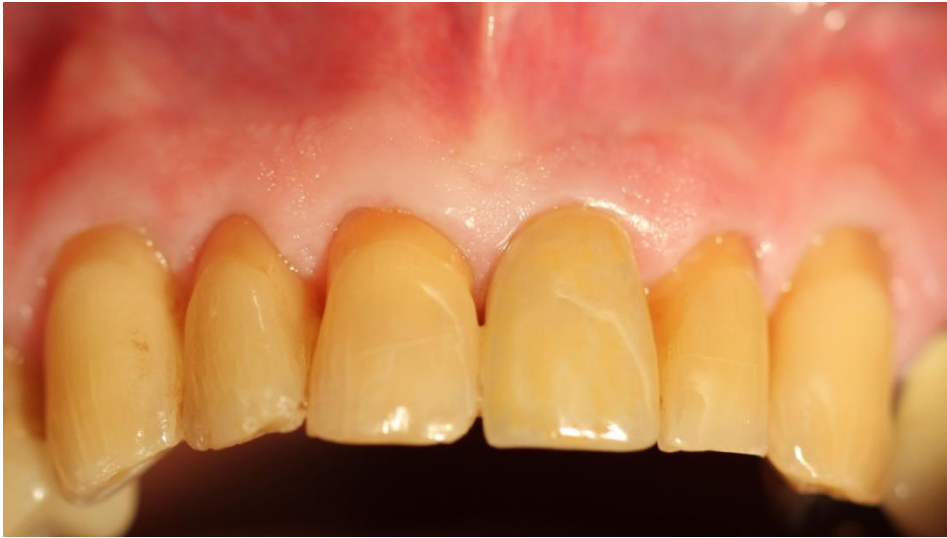
The crown was cemented 9 weeks after implant placement. This photograph was taken 5 weeks after crown cementation and 14 weeks after implant placement. From a surgeon's perspective, the collaboration between the restorative dentist and laboratory technician has produced a remarkable esthetic result. Essex retainer and restorative dentistry courtesy Dr. Mike Gide.

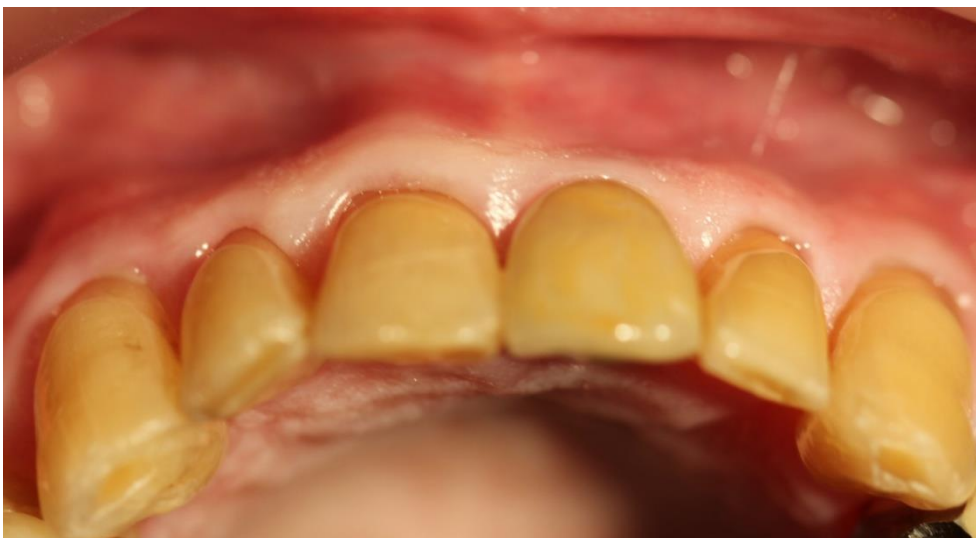
The buccal view shows a slight loss of buccal contour on tooth #9. The crown is slightly over contoured in the apical third. However, this has not affected overall esthetics or the gingival margin.
