## Diagnosing and Treating a Hollow Jaw

## CASE 1

## **CASE 2**

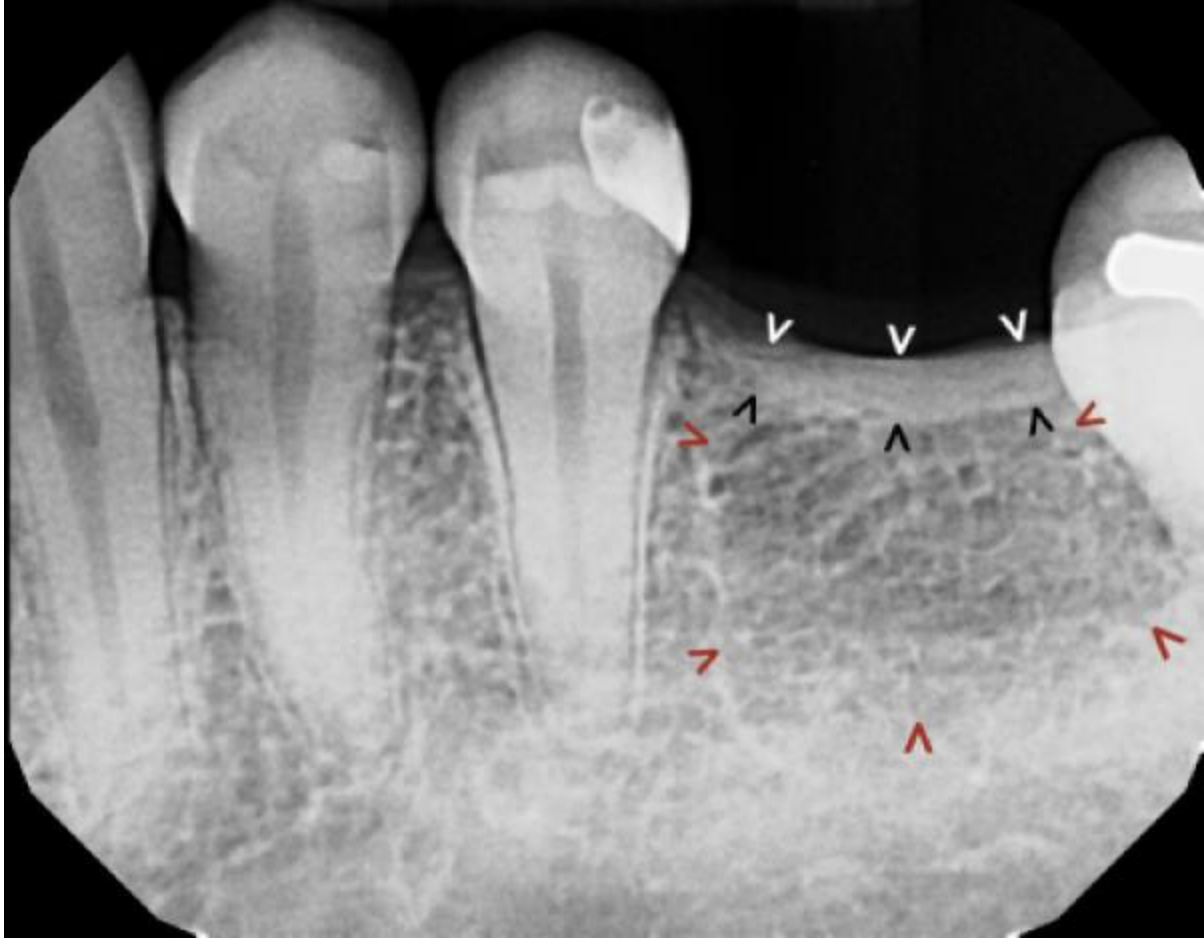
The white and black arrows show a thickened crestal cortical bone that is compensating for the poorly mineralized cancellous bone. The cancellous bone lacks radio density as outlined by the red arrows.

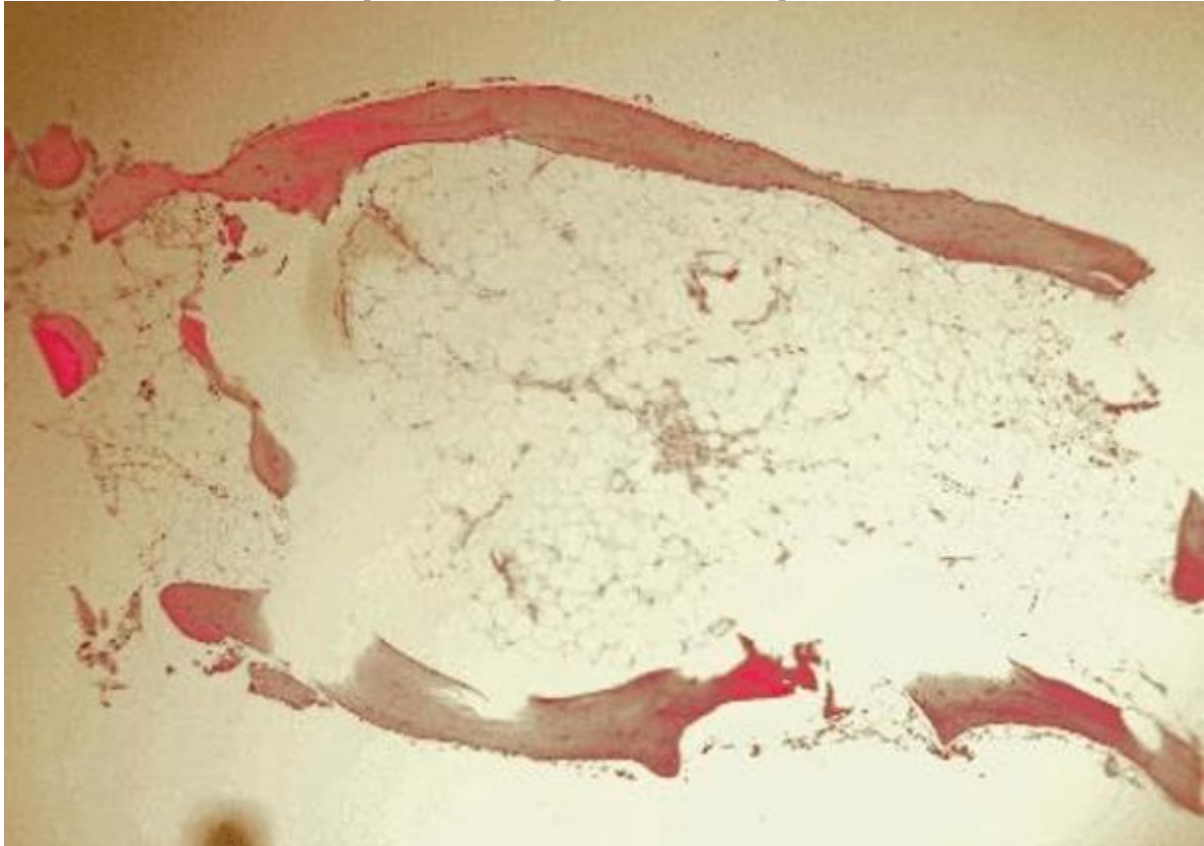
Trephine sample

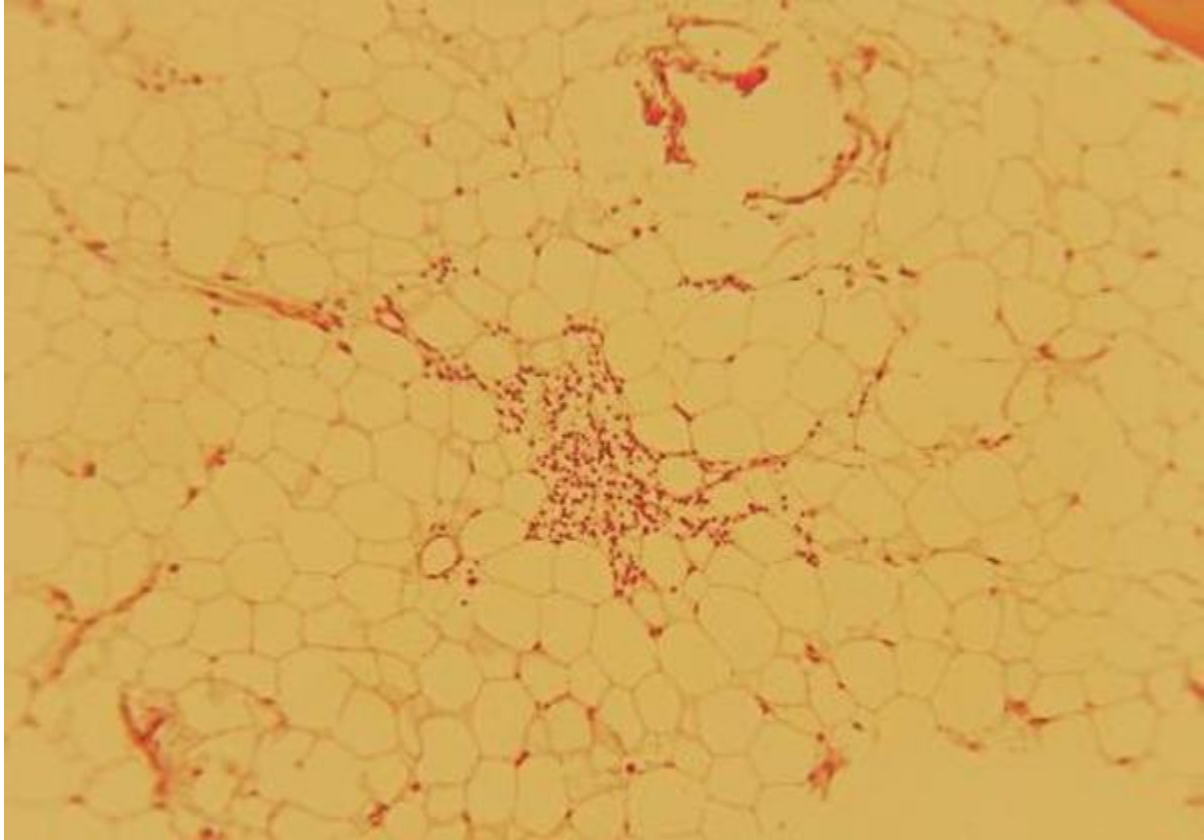
Fat cells with inflammatory cells

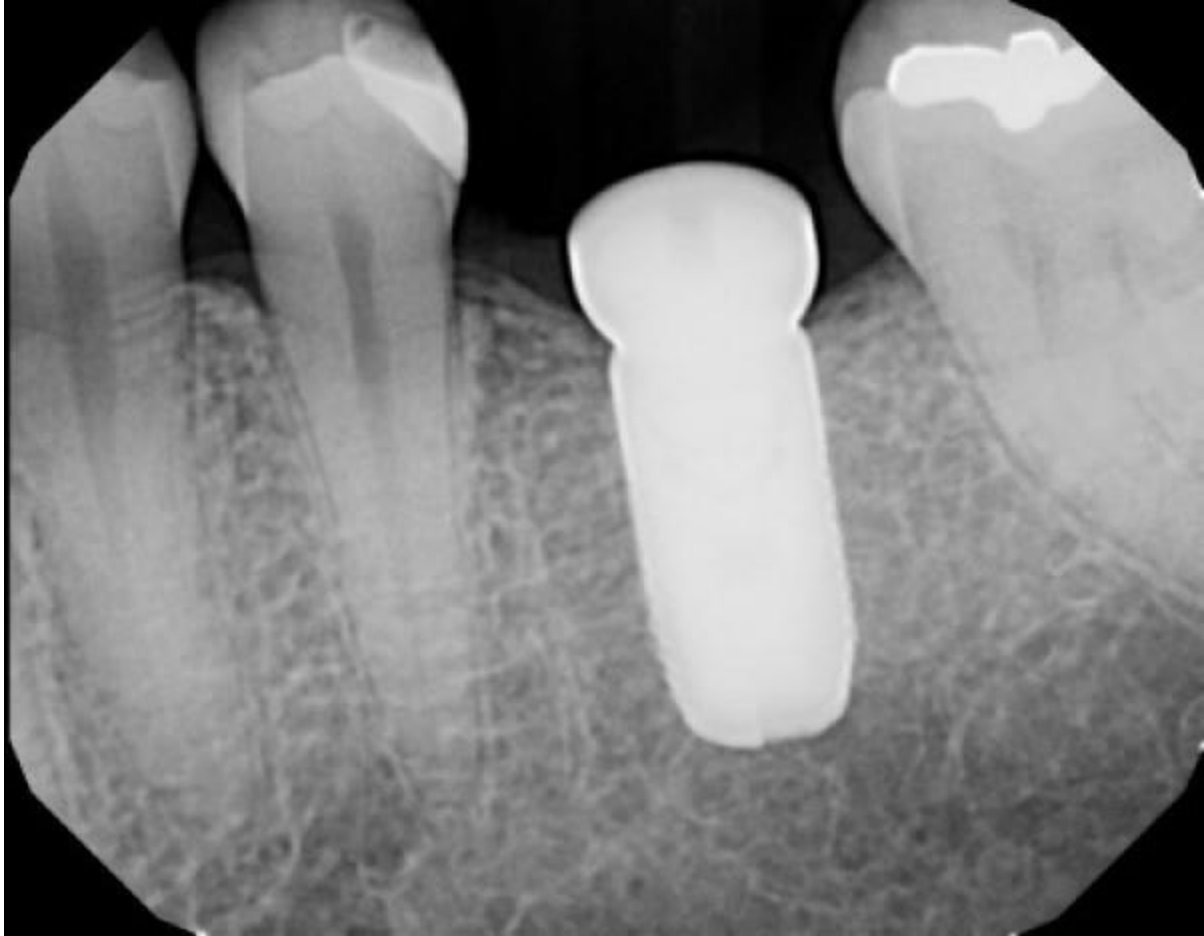
The following radiograph was taken three months after grafting with BioDensification™ and implant placement. The radiograph shows successful regeneration of the cancellous bone with a good dense trabecular pattern in addition to a remodeling of the thickened crest as the anatomy returns to normal.

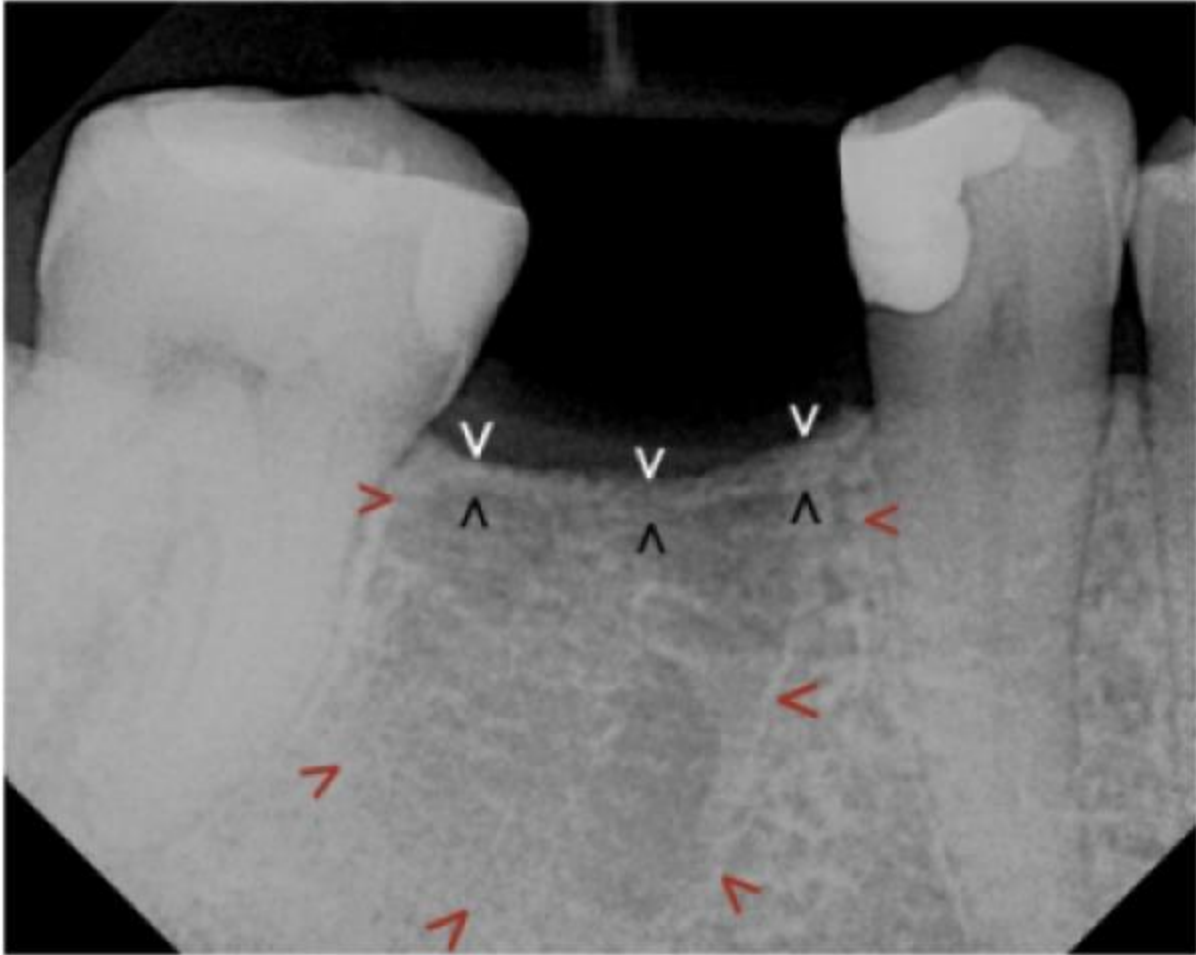
The white and black arrows show a thickened crestal cortical bone that is compensating for the poorly mineralized cancellous bone. The cancellous bone lacks radio density as outlined by the red arrows.

A trephine biopsy was attempted. However, once the mineralized crest was penetrated, the tissue beneath the crest was crushed and a biopsy was not able to be harvested due to a lack of mineralization.

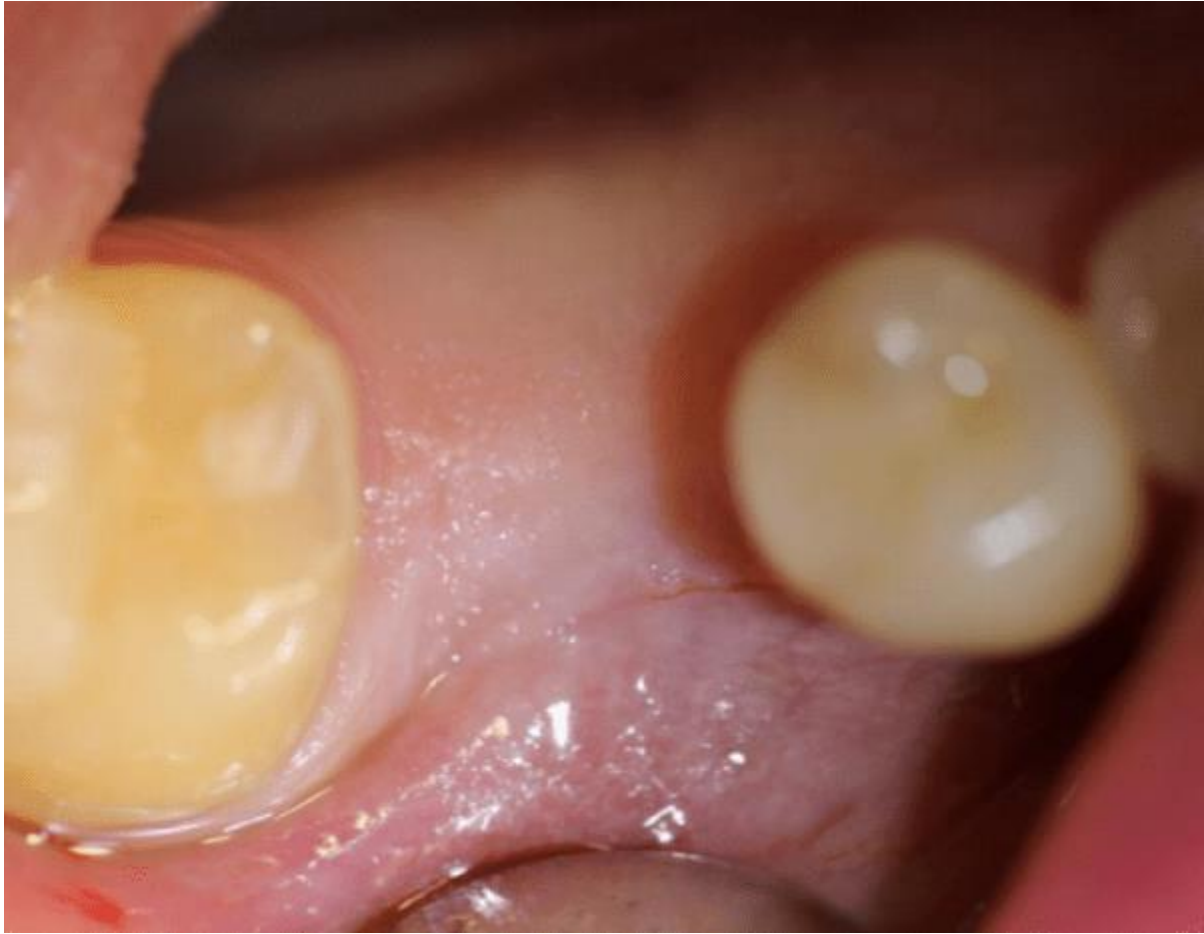
Pre op ridge shows loss of buccal ridge height and width.

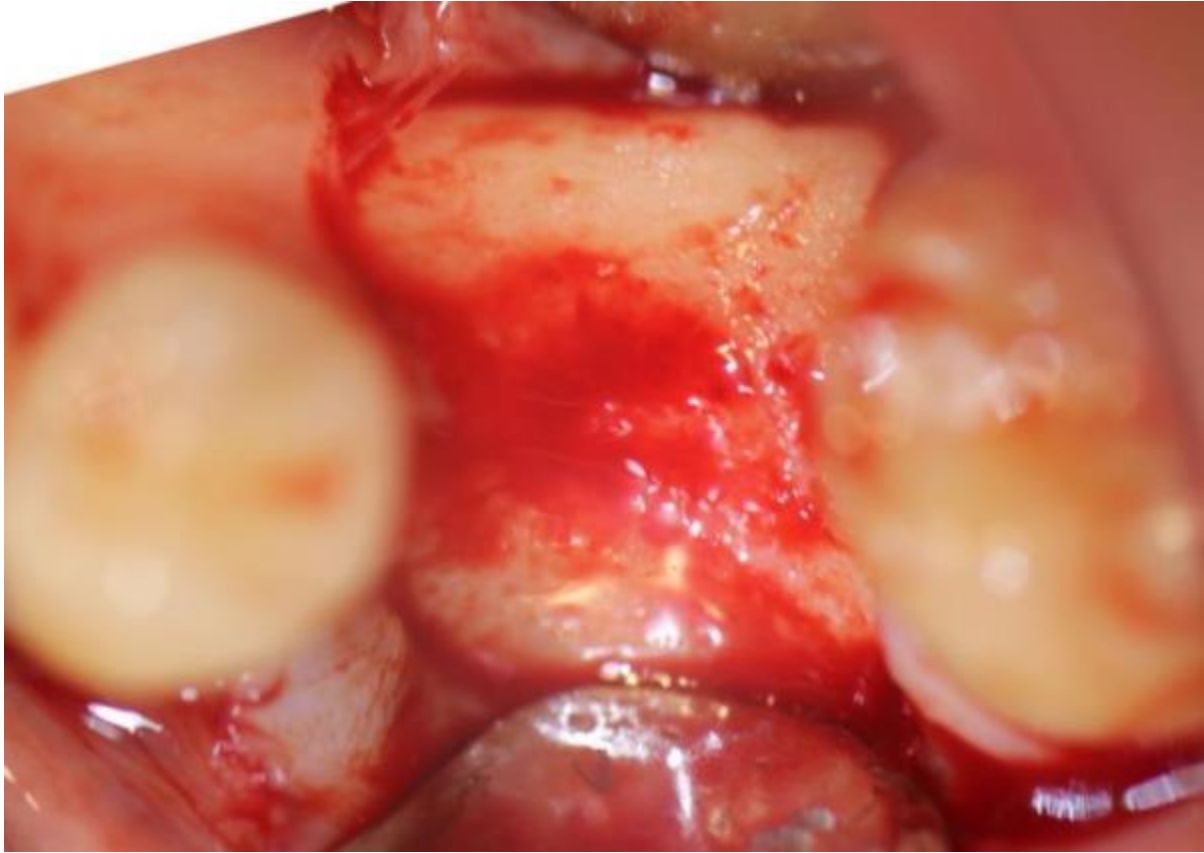
The ridge sloped significantly to the buccal.

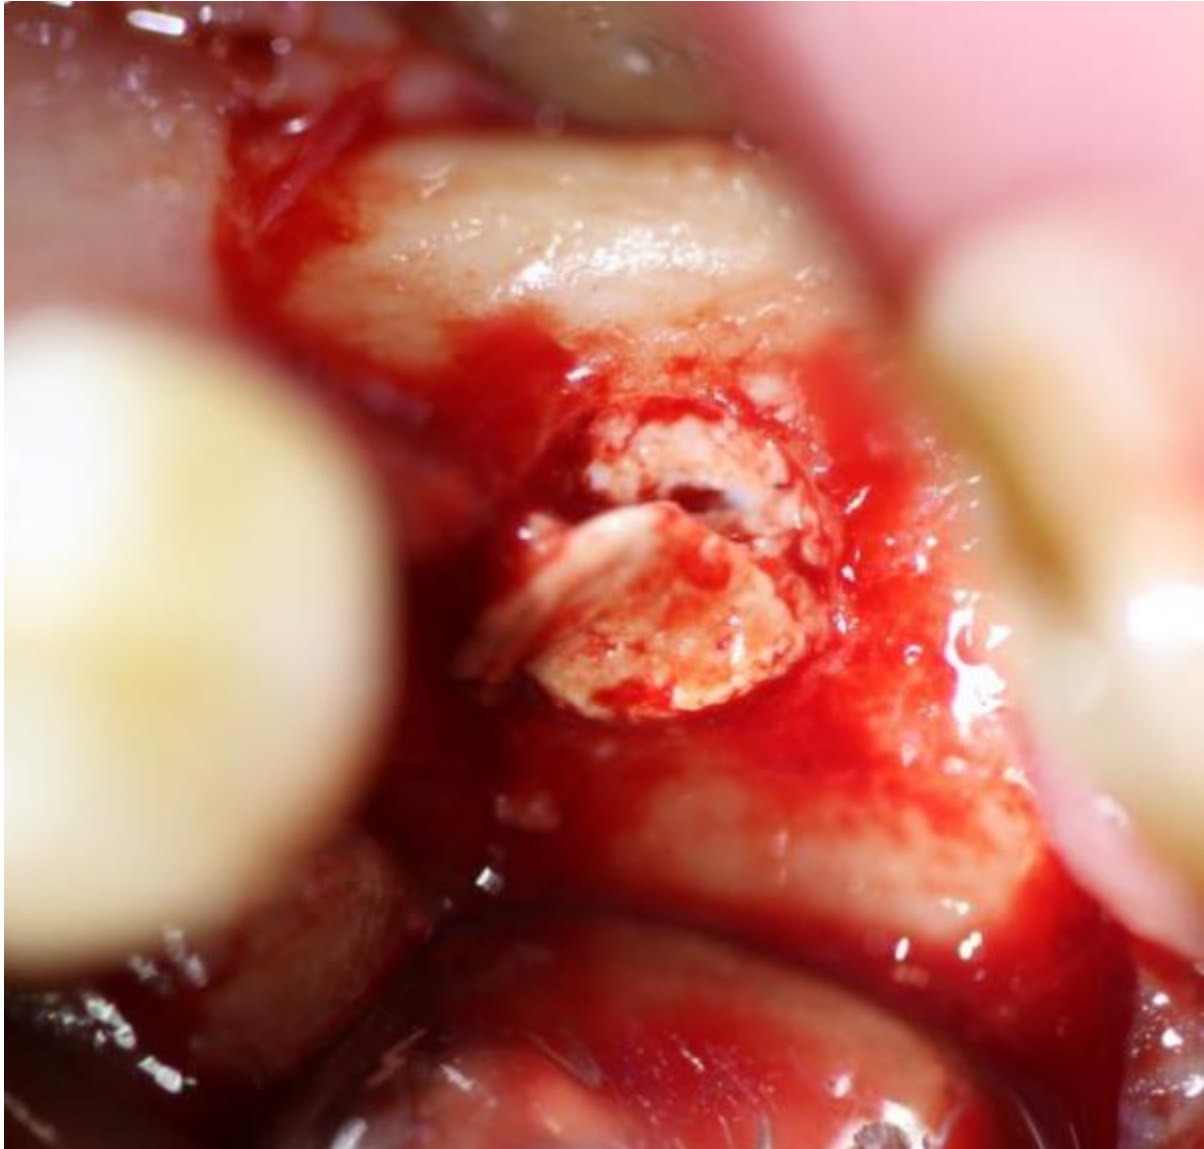
After piercing the crest, no resistance was found during the osteotomy. To improve the vitality of the bone and increase bone density, the osteotomy was filled with BioDensification™ shown here.

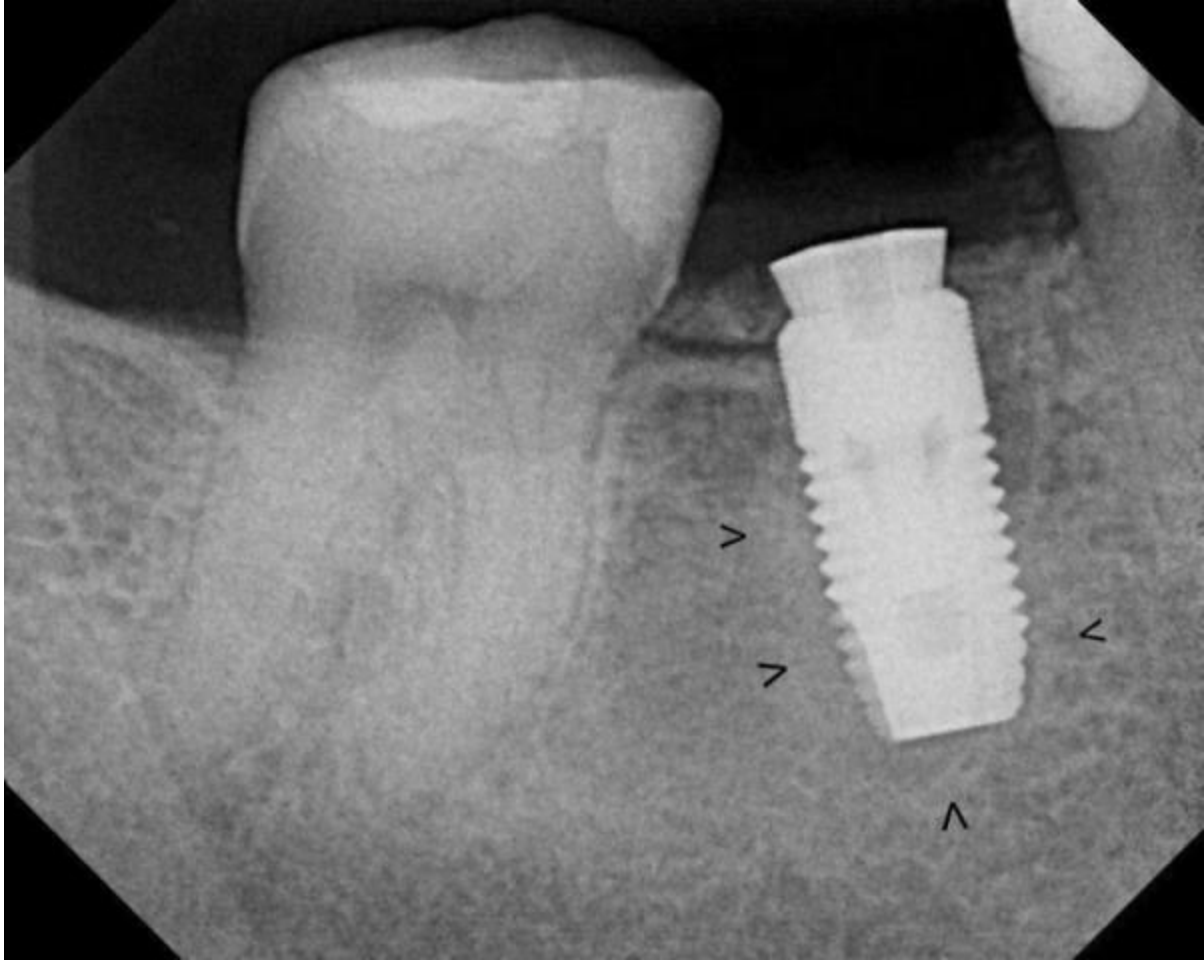
The implant was placed which dispersed BioDensification™ into the mandible as noted by the black arrows.

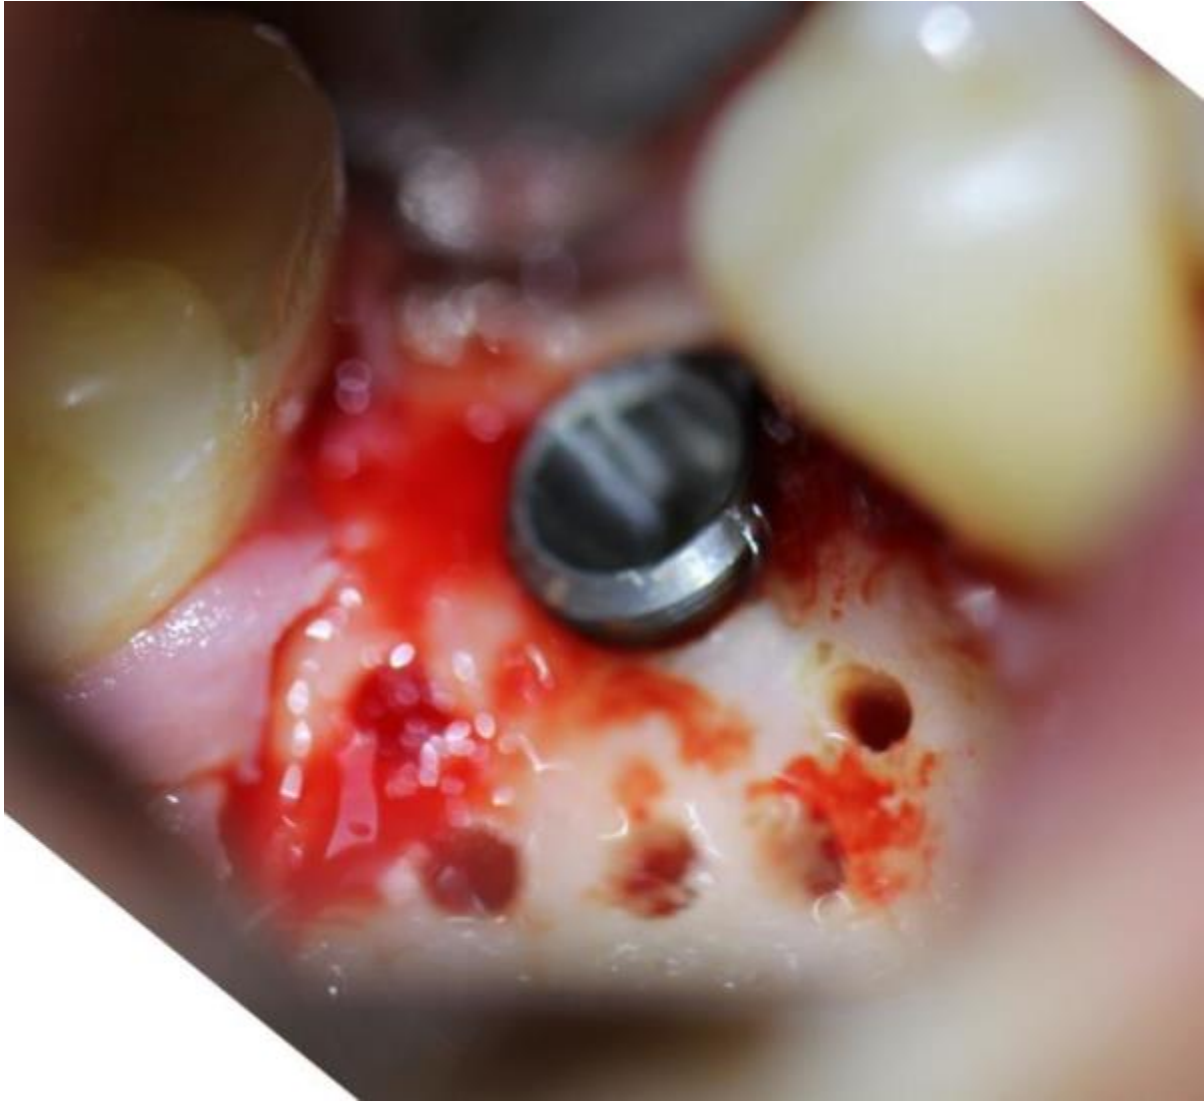
In an effort to correct the ridge slope and cover the threads the buccal ridge was prepared for grafting. The perforations need to be made to a depth that results in bleeding to gain access to regenerative cells.

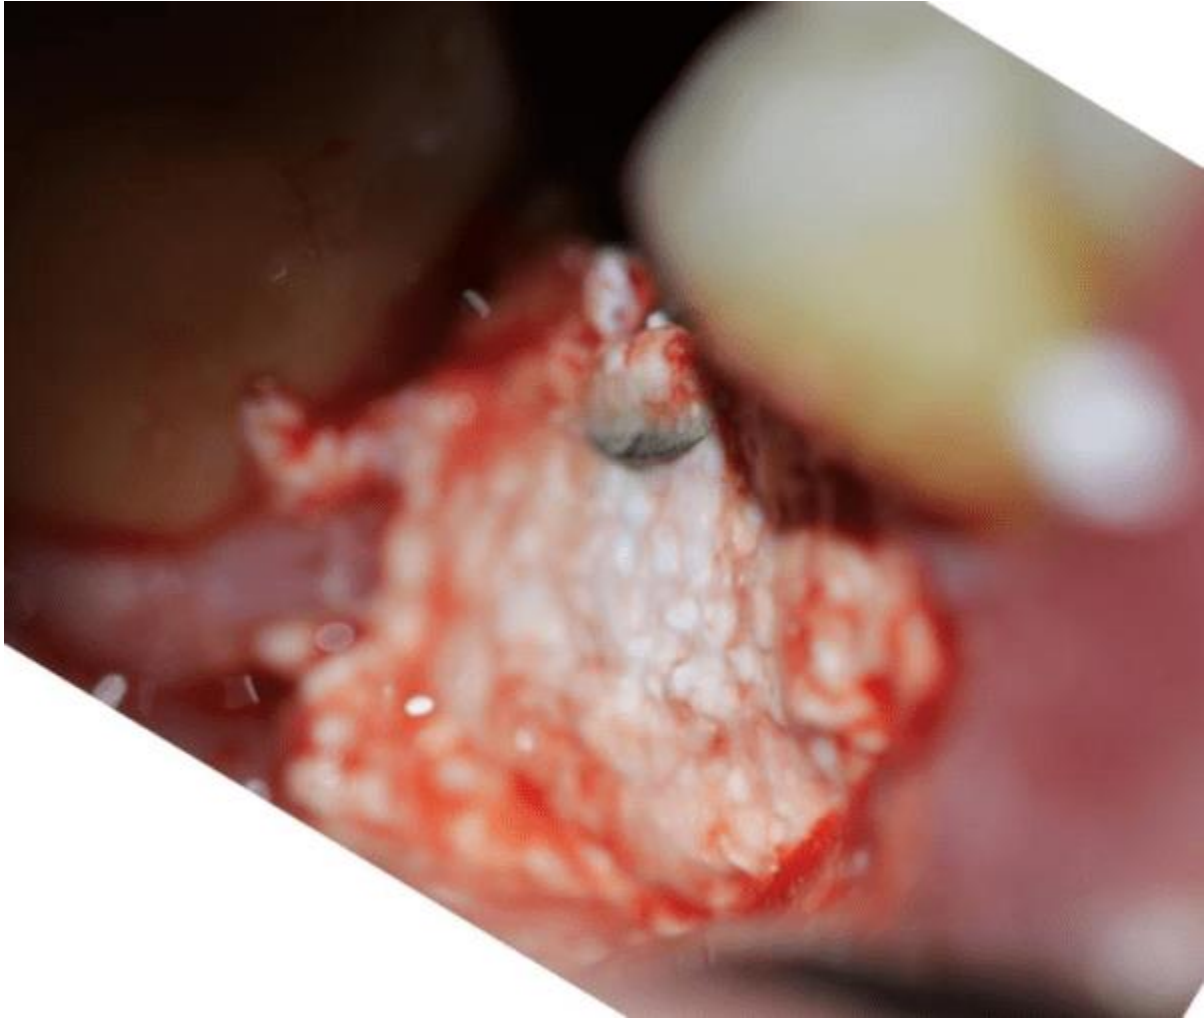
The buccal ridge was grafted with Socket Graft™ mixed with OsseoConduct™  $\beta$ TCP perio granules.

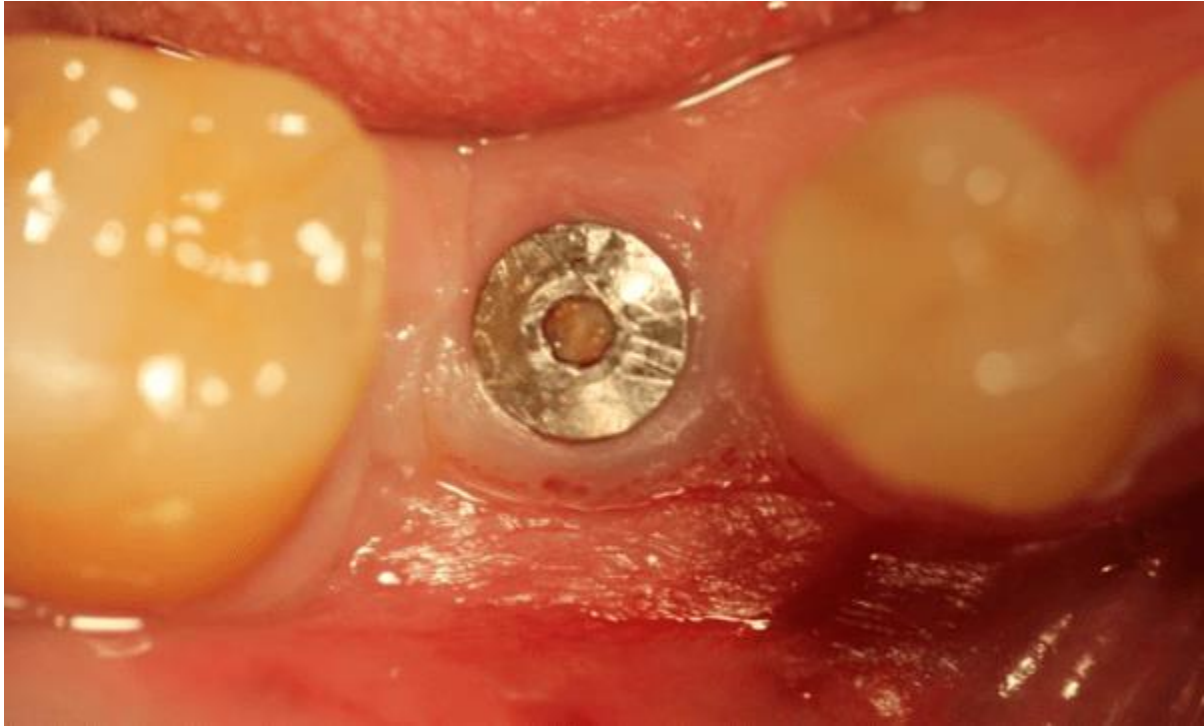
Healing abutment appointment three months after grafting.

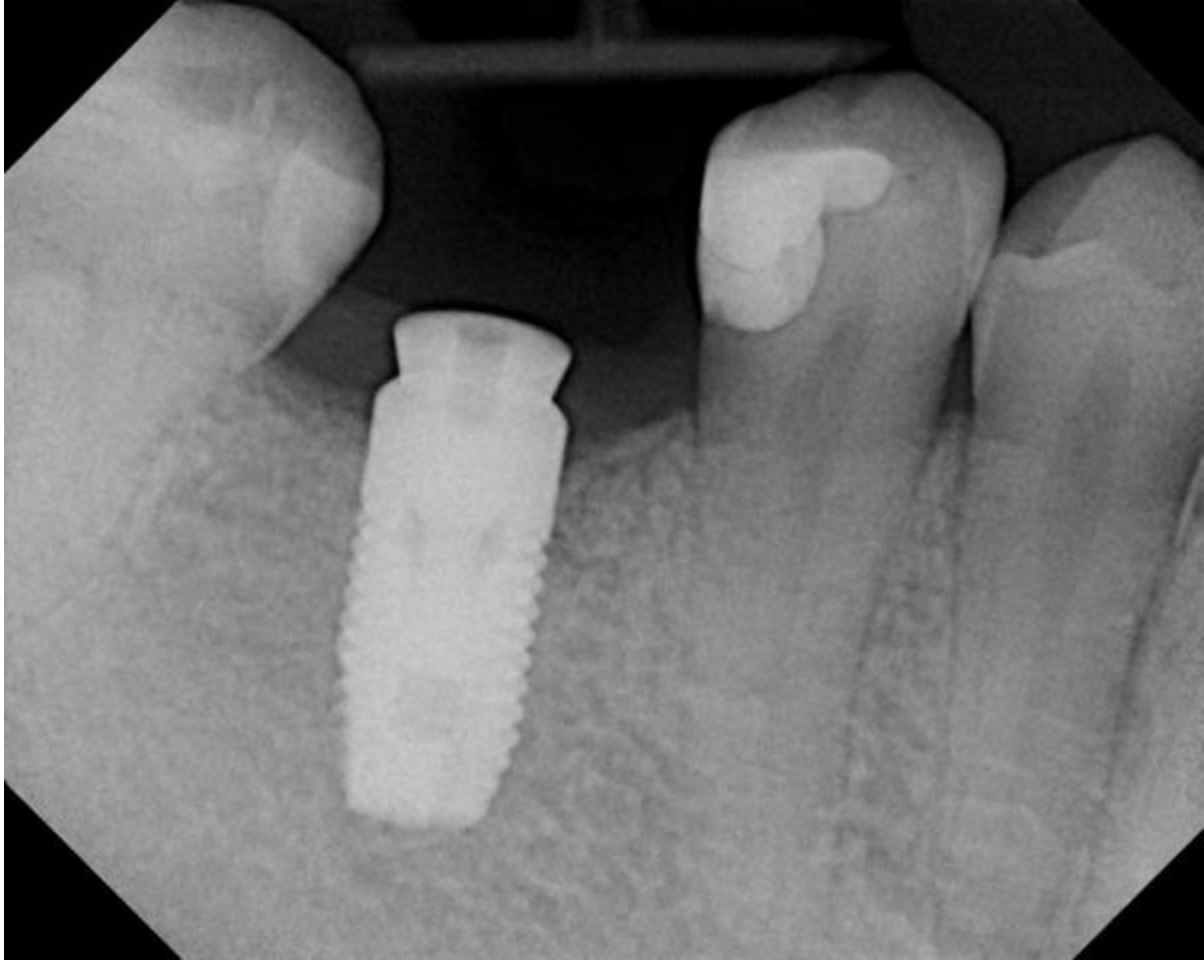
At the healing abutment appointment, three months after implant placement and grafting with Socket Graft™, the bone is well mineralized and has a density comparable to the surrounding healthy bone. The bone around the implant shows fine trabeculation that will continue to mineralized and reorganize for the next three months.
