## Gingival Esthetics and Bone Grafting Immediate Implants

The following case illustrates how to correct gingival problems associated with buried immediate implants and also discusses the effects of incomplete graft fill around grafted immediate implants.

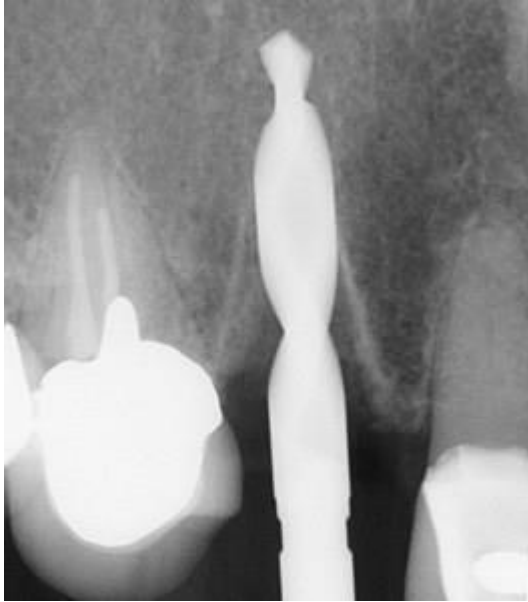
This patient is an 87 year old female presenting with an unrestorable maxillary canine. An immediate implant is planned.

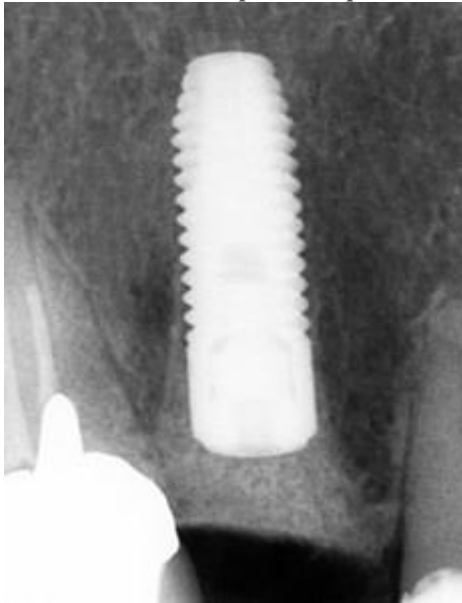
The implant is placed and grafted with [Immediate Graft™](#). Since it was not possible to take this canine out of lateral excursive occlusal contact, the immediate implant was not temporized but buried at the time of placement.

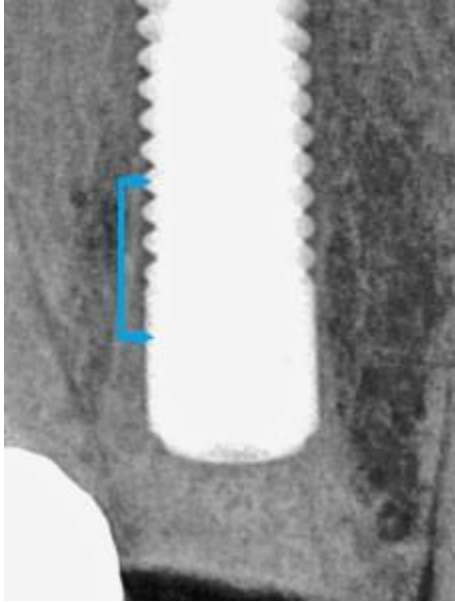
A closer look at the grafted area on the previous radiograph shows an area on the implant that was not adequately grafted. There is a small void in the area outlined by the arrows.

A closer look at the same radiograph three months after grafting shows a lack of bone contact where the graft material failed to fill the void. Three grooves and the apical extent of the microthreads have no bone contact. This radiographic image documents the requirement of the bone graft to be in contact with the implant surface for bone to implant integration to occur. We will revisit this area 2 years after loading.

After two years of function, bone covers the entire crestal portion of the implant. However, what about our void? Close inspection shows bone fill onto the threads and up to the microthreads but integration has not occurred in the area of the bone graft void. It is obvious the bone is in contact with the top of the threads but has not filled the grooves. The definition of osteointegration requires that bone must fill the groove not merely contact the threads.

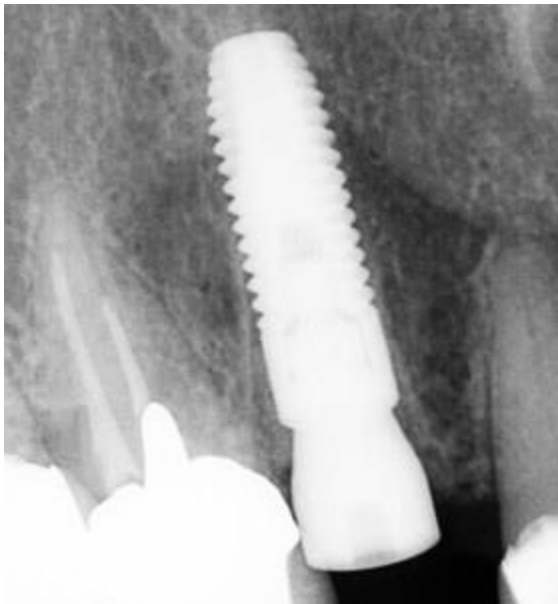
Three months post op.

The healing abutment is placed showing excellent mineralization of the crest around the implant.

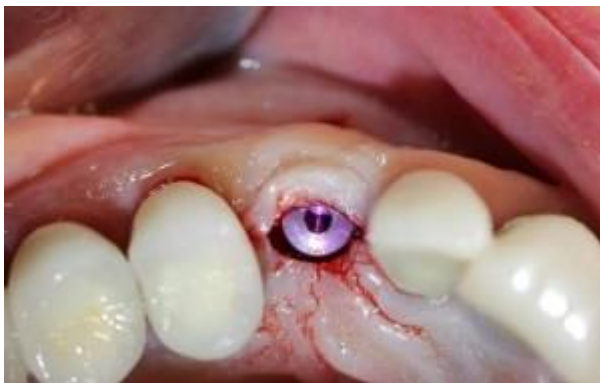
At the healing abutment appointment, the photographs show maintenance of the buccal prominence with no buccal bone resorption. However, invariably there is collapse of the gingival margin compromising esthetics. In this case sulcular incisions are made on the adjacent teeth and carried to the lingual of the crest.

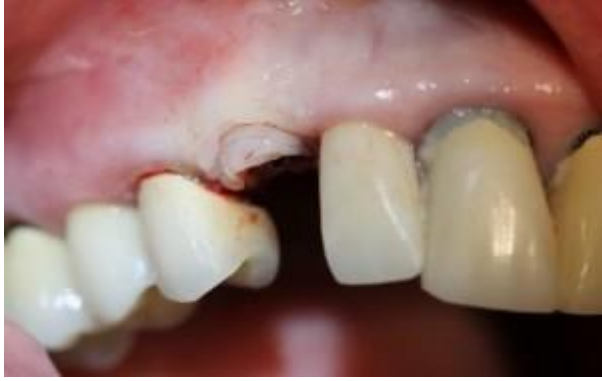
The crestal gingival is moved buccally to fill in the buccal gingiva over the buccal prominence. The vertical aspect of the gingiva is restored by inverting the flat crestal gingiva. The healing abutment holds the uprighted gingiva in place.

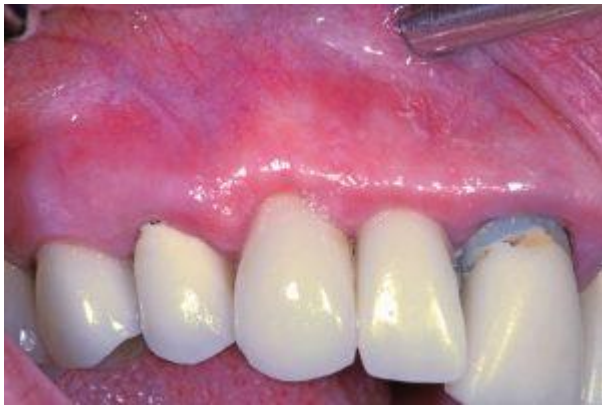
This photograph was taken two years after restoration. Nothing was done to the gingiva after the healing abutment appointment. The gingiva remodeled itself producing an excellent esthetic result.
